# Jeep CJ, YJ, and TJ Hardtop Seal Kit

## Part Number : 12304.07

### Installation Instructions.

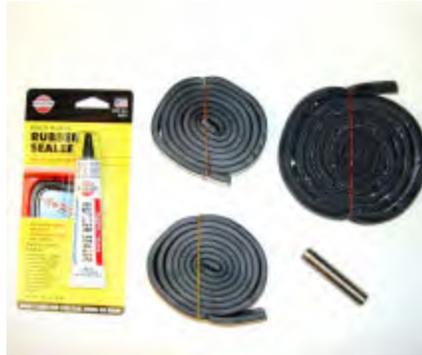
- Kit Contains:**
- (1) Tube of rubber repair glue
  - (1) 3/4" wide extruded gasket material
  - (2) Rolls of 1" wide foam tape
  - (1) Hardware hole punch
